Name Of Dam: DIXIANA DAM
Location: WISE COUNTY, VIRGINIA
Inventory Number: VA. NO. 19505

PHASE I INSPECTION REPORT

NATIONAL DAM SAFETY PROGRAM

SCHNABEL ENGINEERING ASSOCIATES, P.C./
J. K. TIMMONS AND ASSOCIATES, INC.

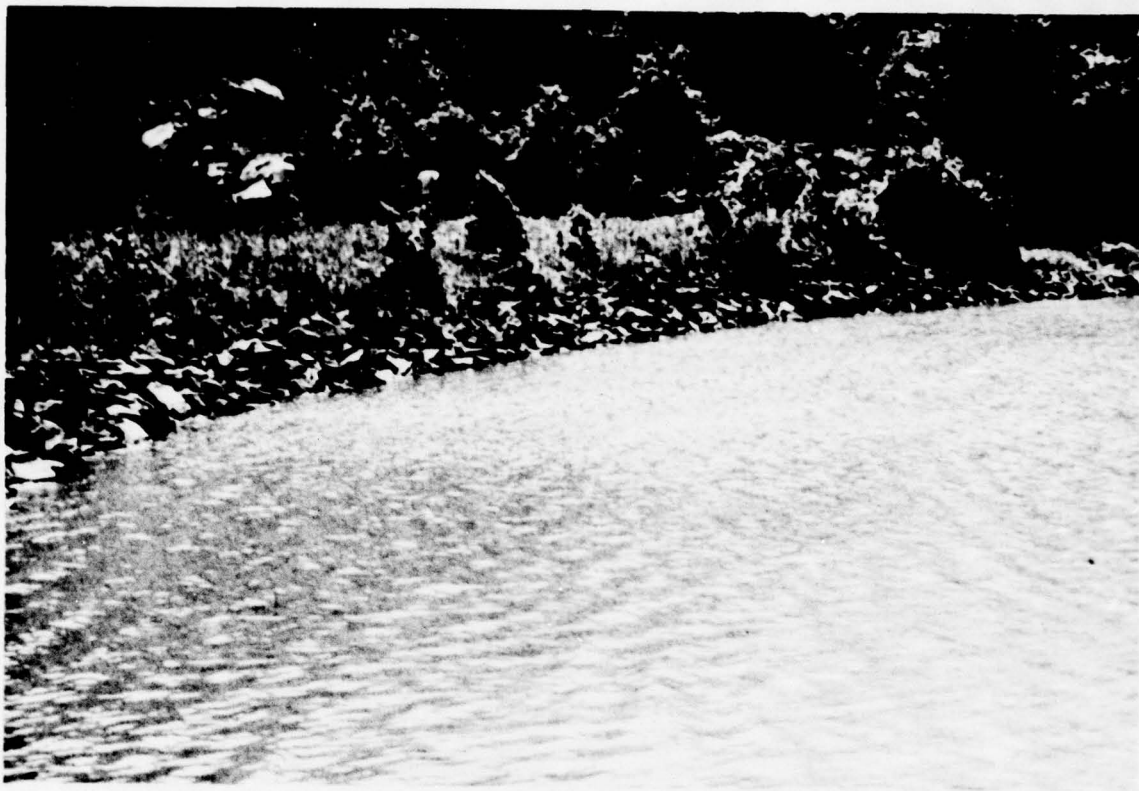
VIEW OF UPSTREAM FACE OF DAM AND RIP RAP
